MAKE SURE THAT STOVE DOESN'T TIP!

Many property owners don't realize that anti-tip devices are required for units inspected by MBHP.

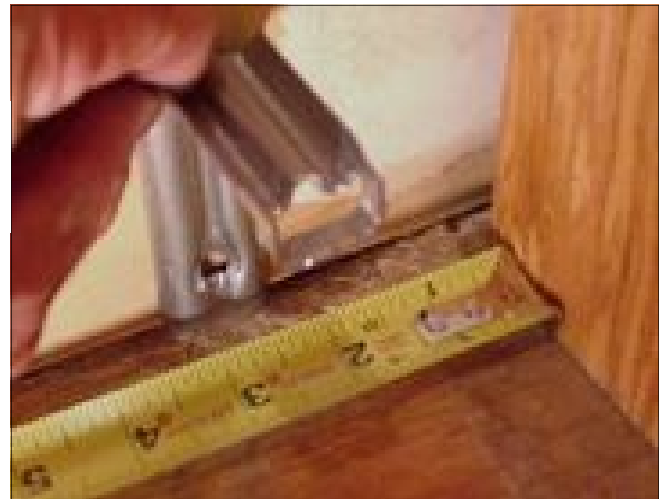
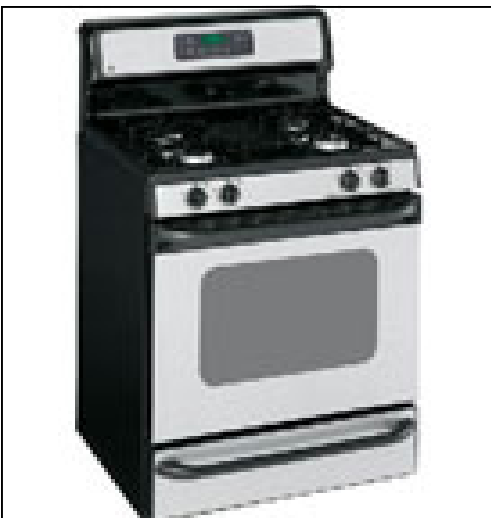
An anti-tip bracket is generally attached to the bottom of the wall behind the stove, and clips to the rear legs. This allows the stove to be moved for cleaning and maintenance. If you do not have the original bracket which was supplied with the stove, brackets can be purchased at any home center or appliance store.

Anti-tip brackets can be purchased at any home center or appliance store.
