MAKE SURE THAT STOVE DOESN'T TIP!

Many property owners don't realize that anti-tip devices are required for units inspected by MBHP.

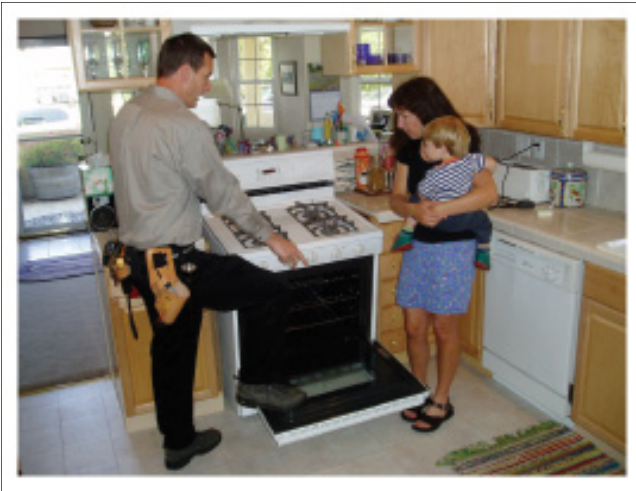
Stove tip-overs frequently occur. If a child steps on an open oven door, or a heavy pot is placed on an open door, the door acts as a lever and forces the stove to tip.

The proper installation of a stove requires the attachment of an anti-tip device. These devices are included with all new stoves, but often are not installed.
